B.6 – TERRAIN FEATURES

B.6.1 INTRODUCTION

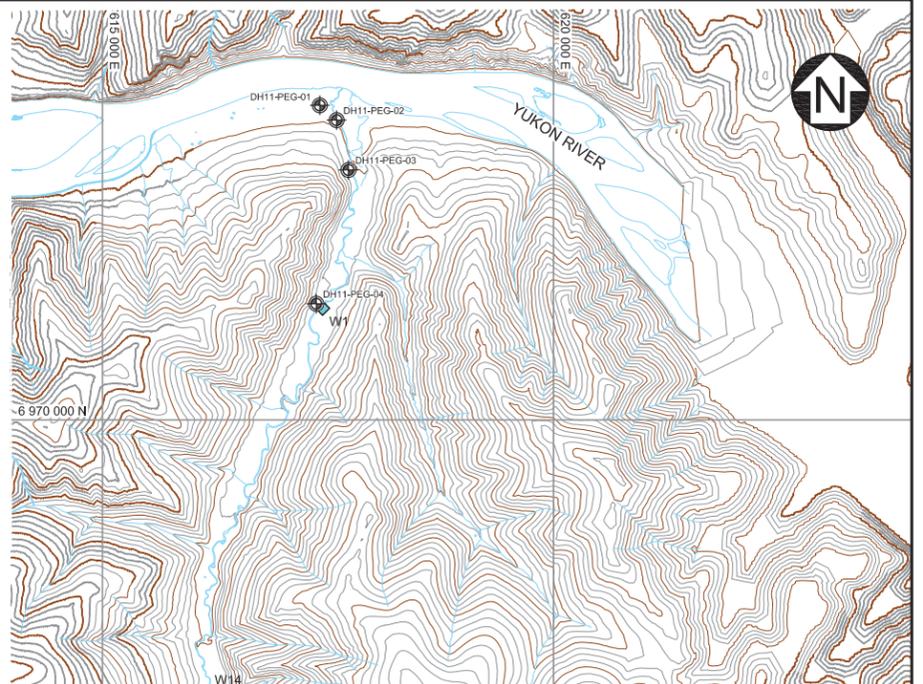
FOR DETAILS SEE INSET

- b. Updated thermistor data is provided in the 2013-2014 Groundwater Data Report, provided in Appendix A.7M, specifically Appendix D of that report.
- c. The locations of all installed thermistors are shown in Figure B.6.4-8. No 1994 thermistor locations are proximal to locations where temperature data has been more recently recorded. Therefore, inferences as to long-term trends in mean annual ground temperatures are not possible.
- d. Hydrogeology data in and around the mine site, including continuous groundwater level and ground temperature monitoring, and groundwater quality sampling continues to be collected as part of the on-going environmental monitoring program. Baseline studies will be updated and provided in the applications for Quartz Mining and Water Use Licences.
