21 – ACCIDENTS AND MALFUNCTIONS.....	21-1
21.1 INTRODUCTION.....	21-1
21.2 METHODOLOGY .....	21-2
21.2.1 Risk Identification and Analysis.....	21-3
21.2.2 Risk Evaluation and Ranking .....	21-4

Figure 21.2-1 Accidents and Malfunctions Risk Assessment Methodology ..... 21-3  
Figure 21.2-2 Accidents and Malfunctions VC Interaction..... 21-5  
Figure 21.2-3 Risk Matrix Template..... 21-6  
Figure 21.5-1 Casino Project Risk Matrix ..... 21-53

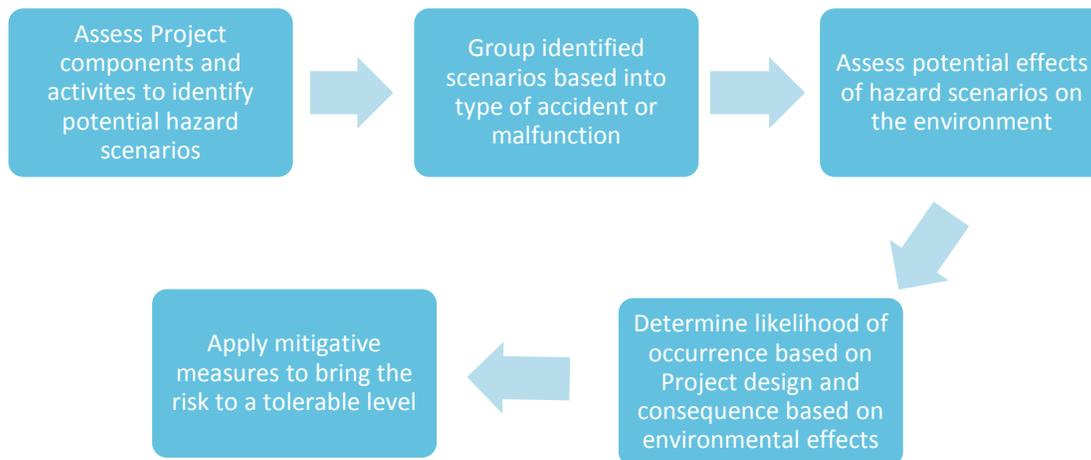
A qualitative risk assessment was conducted for the Casino Project in order to identify all components or activities and potential hazard scenarios that could pose a risk to the Project VCs. Qualitative approaches use descriptive terms to identify likelihoods and consequences of events (Paithankar 2011). The ranking of risks for each hazard scenario are illustrated on a risk matrix. The general approach followed in the assessment is presented Figure 21.2-1 and discussed in the following paragraphs.

**Figure 21.2-1 Accidents and Malfunctions Risk Assessment Methodology**
